# **General Masonry Repair Recommendations**

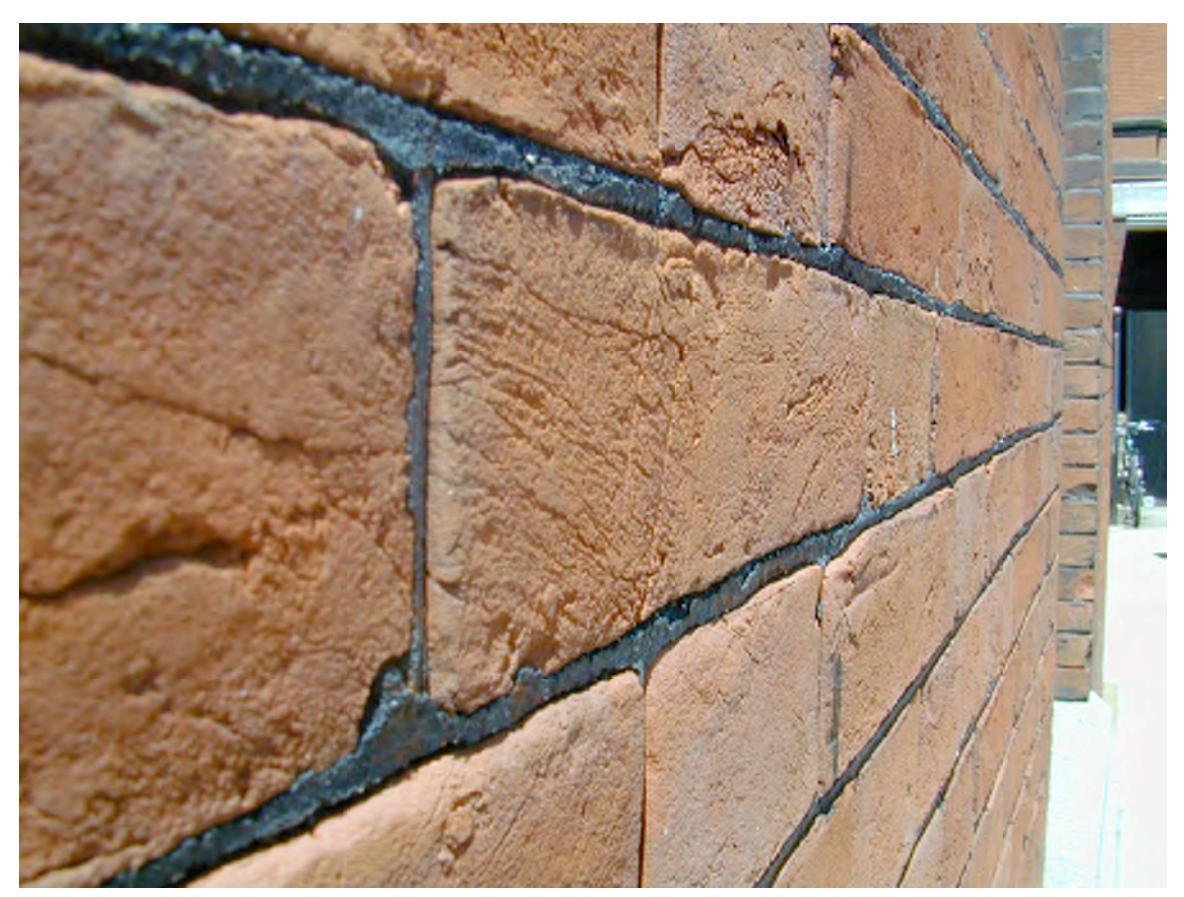
This section of protected original ground-floor pointing still exhibits the impact of the original pointing.

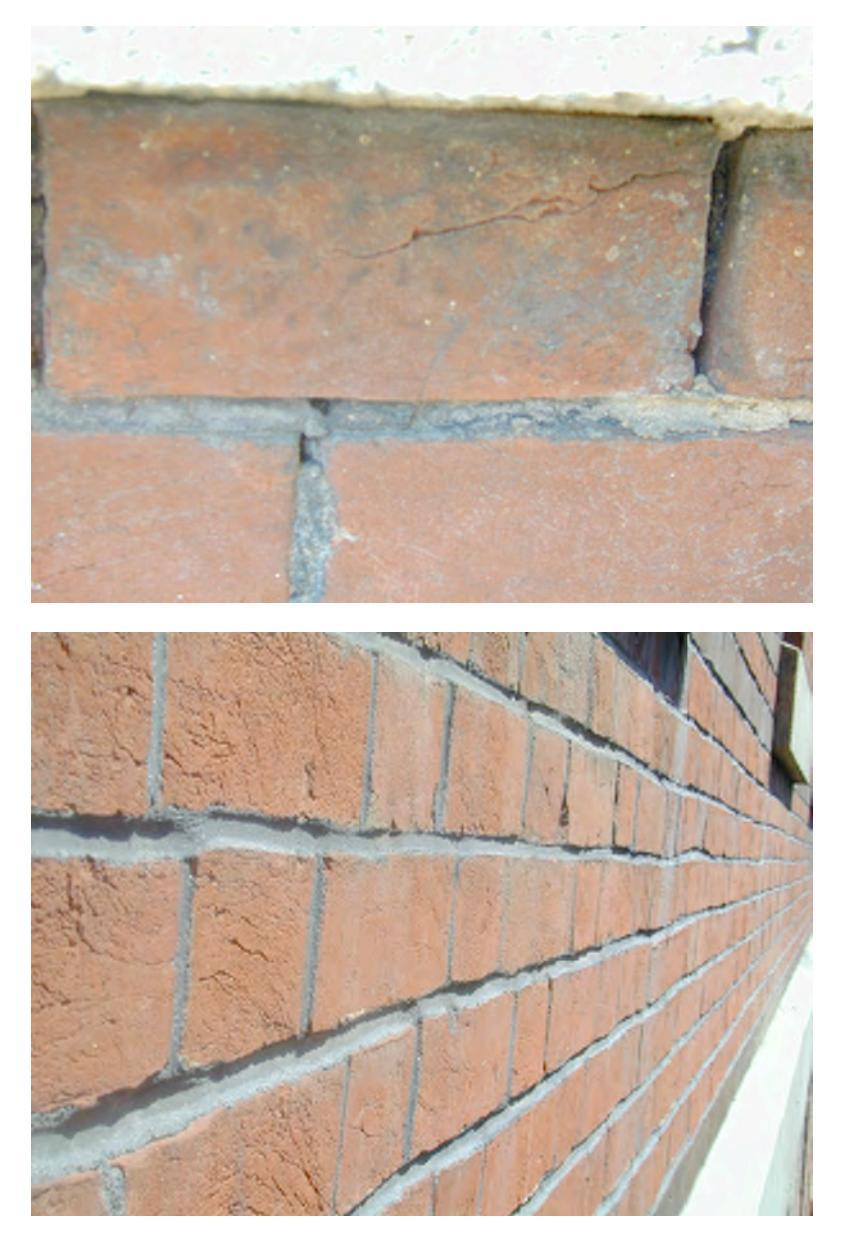
In contrast, heavily deteriorated original pointing is recessed and the lime has been leached to the surface from acid rain attack.

Areas that have been cut with grinders and portland repointed leave only a negative impression.

The original mortar is overloaded with pigment making it weak. This large quantity of pigment filler becomes in a sensse aggregate in the mortar and changes the ratio from 3:1 to 6:1 making it unlikely that the lime could properly coat and bind all of the aggregate together. This is a problem often faced in using dark pigmented mortars. Half of the aggregate is fine clear quartz silica and half a ground carbon acting as pigment. With the tinting coming from crushed carbon which has much less hiding power than finely divided pigments of the same volume, the mortar is automatically weaker. The replica mortar can be made with more stable natural iron oxide pigments.

For both water-shedding and aesthetic reasons we recommend removing the modern portland repointing in place on much of the ground floor, but this work is not as urgent and could be deferred until a later time.

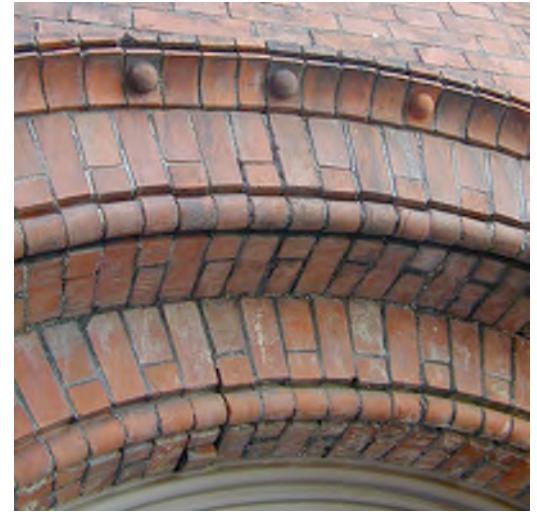
This out-of-alignment appearance is particularly apparent in the window arches trimmed with a double-quirk corner bead constructed through the repetition of a single brick unit flipped over and reversed to correspond to the bonding pattern, with the problem being that it is not symmetrical around the center line of the bead. This is the result of being formed and fired, as opposed to shaped, thus making a unit that is impossible to lay smoothly.

Either the shoulder is out, or the bead is out ... or both. In some cases the masons tried to align the shoulders, leaving the beads out of alignment; in other cases, they laid the beads in line and the shoulders are out of alignment; in still other cases they tried to "cut the difference."

There is no way to make the shoulders or the beads exactly in line with one another without creating some other jagged line.

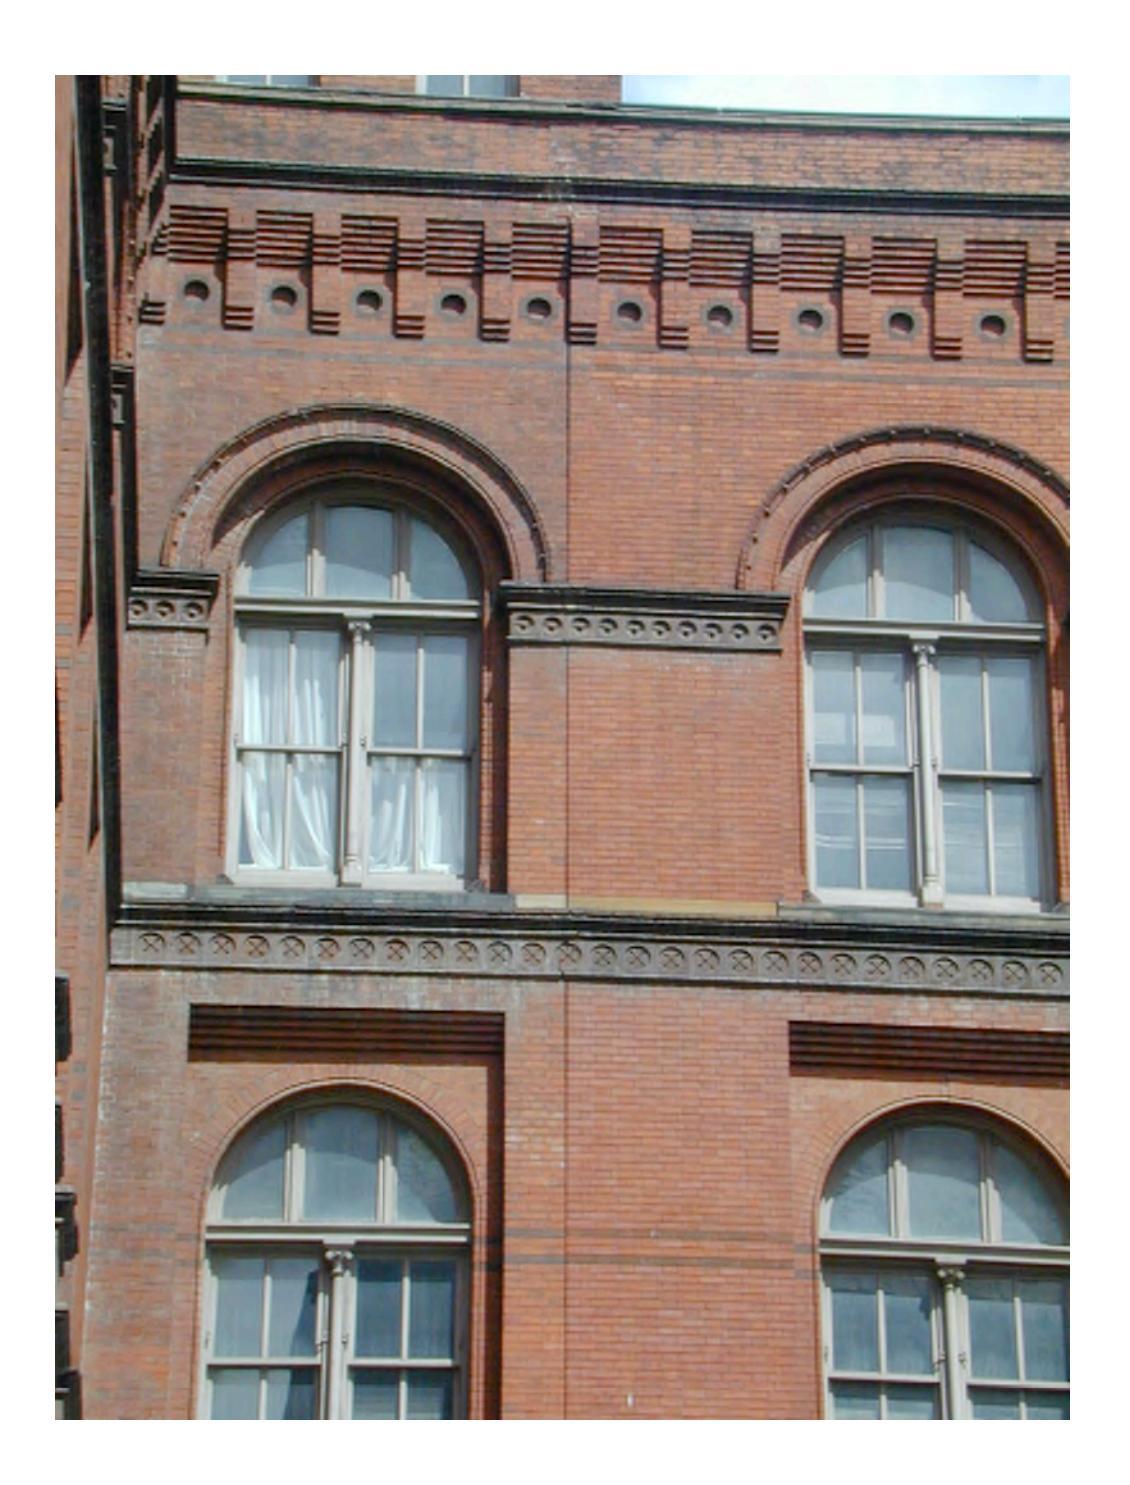
Where the belt course continues from one construction era to another and vertical construction joints exist between the two structures, while the belt courses are continuous, it is important to carefully saw-cut the belt courses as well to stop destruction of these areas from thermal expansion and contraction that is otherwise concentrated into a narrow band.
